UNDERWATER BRIDGE INSPECTION REPORT

STRUCTURE NO. 73510

SAUK RIVER

DISTRICT 3 - STEARNS COUNTY

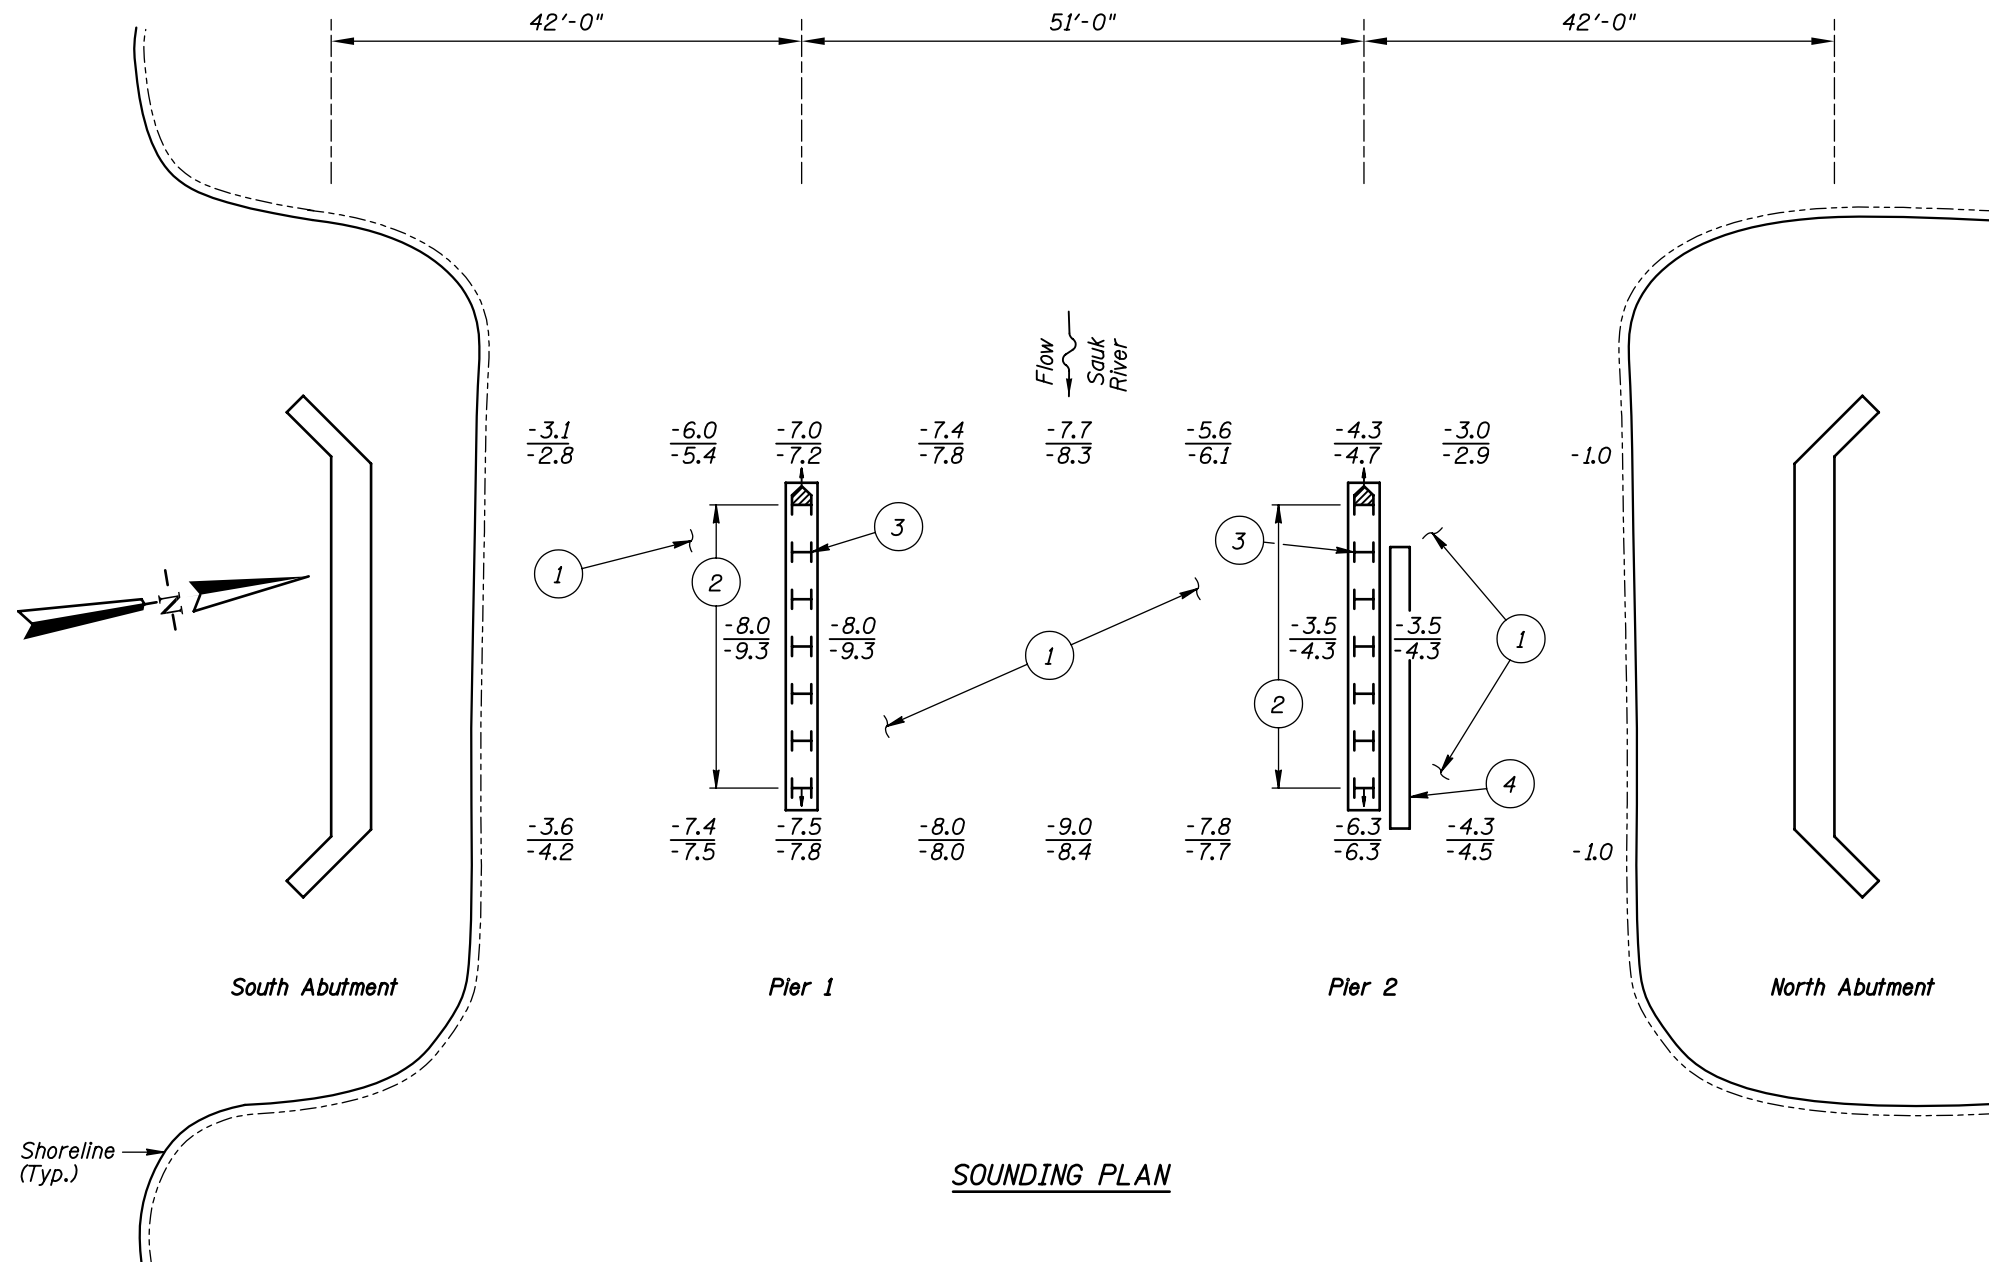
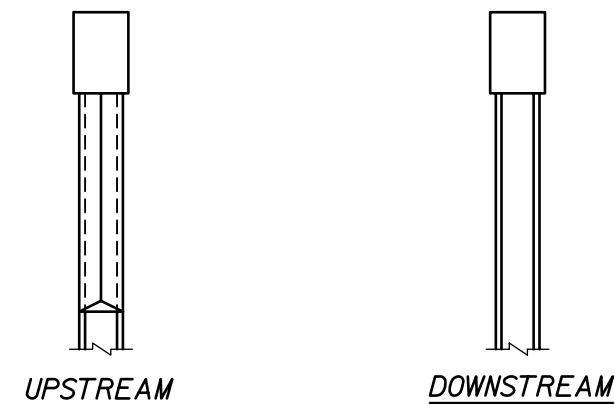
Drawn By: PRH	COLLINS ENGINEERS, INC. 300 W. WASHINGTON, STE. 600 CHICAGO, ILLINOIS 60606 (312) 704-9300	Date: SEPT. 2002
Checked By: MDK		Scale: NTS
Code: 35I20088		Figure No.: 1

- The channel bottom material consisted of sand and 1 to 1.5 foot diameter rock with minimal probe rod penetration.
- Minor surface corrosion and light pitting in conjunction with coating failure/absence was observed on 100 percent of the surface area of the piles from 1 foot above to 4 feet below the waterline, and 25 to 50 percent of the surface area from 1 foot above the waterline to the pier cap. No appreciable section loss was associated with the deterioration.
- Light aquatic growth was observed on all piles below the waterline.
- A steel H-pile was observed on the channel bottom along the north face of pier 2.

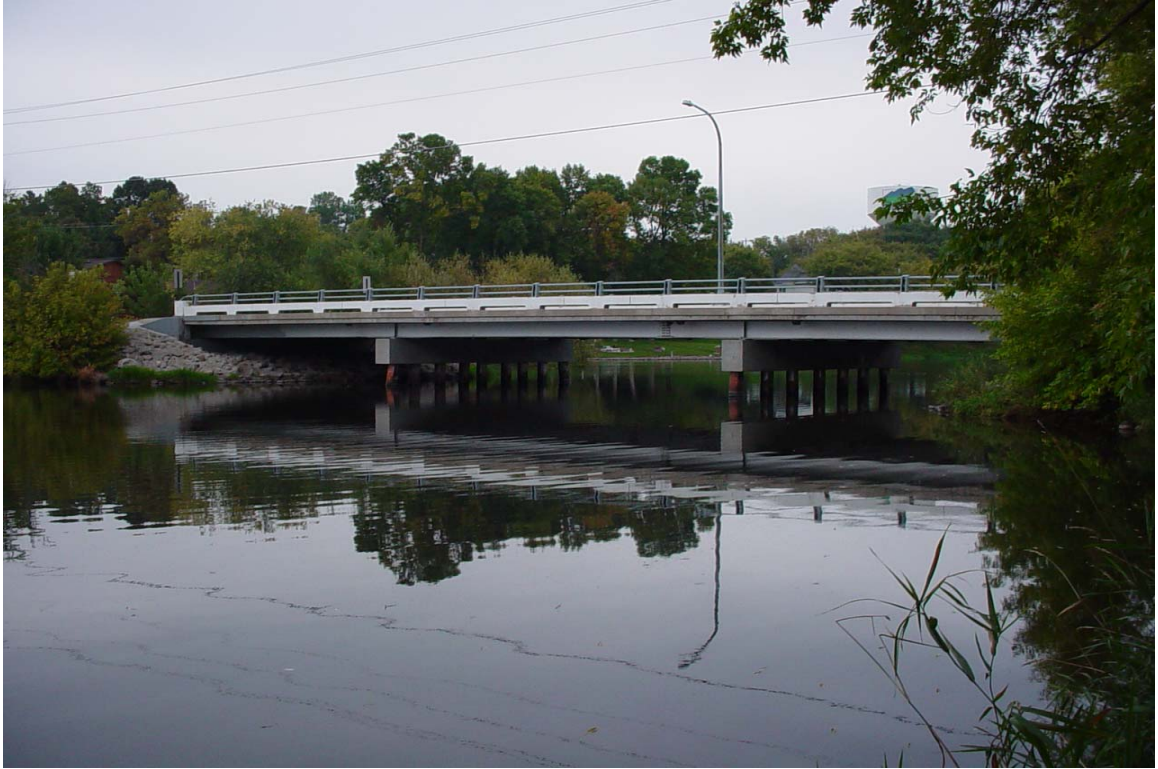
Photograph 1. Overall View of the Structure, Looking Northeast.

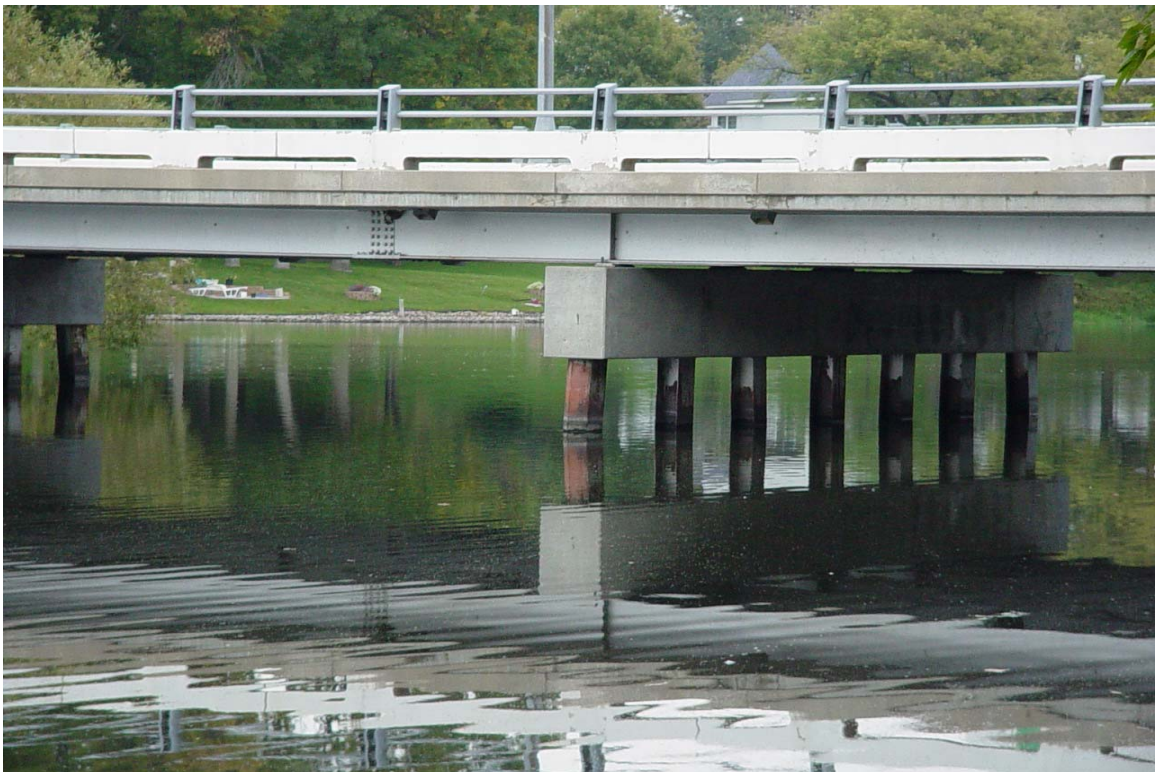
Photograph 2. View of Pier 1, Looking Northeast.

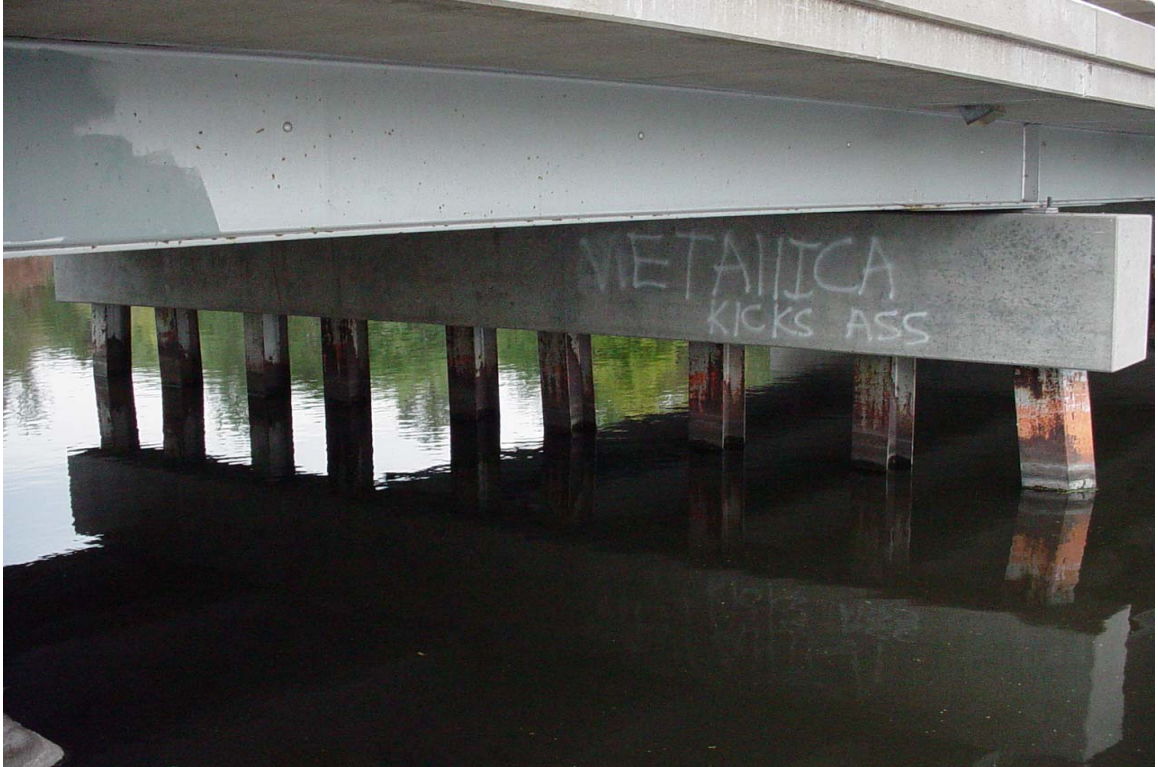
Photograph 3. View of Pier 2, Looking Southeast.

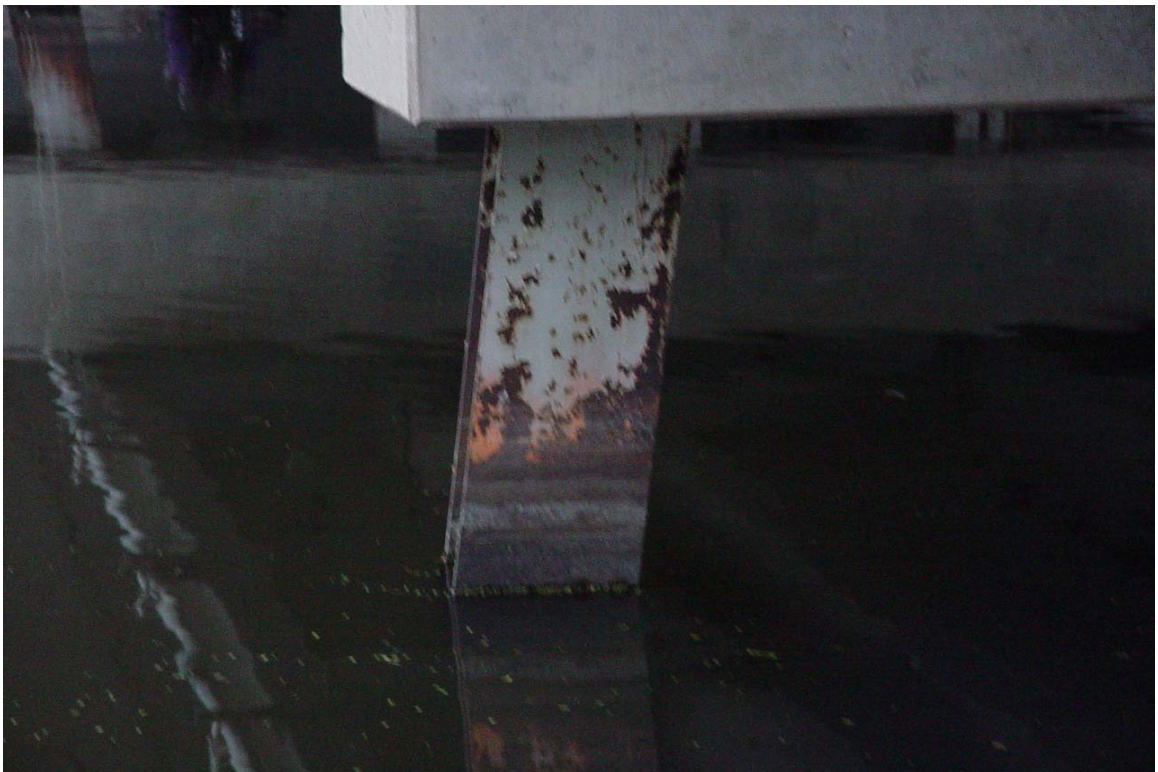
- (A) All steel H-piles of both piers exhibited light surface corrosion and pitting on 100 percent of the surface area from 1 foot above the waterline to 4 feet below the waterline, and on 25 to 50 percent of the surface area from 1 foot above the waterline to the pier cap. This corrosion was related to the coating failure on the steel H-piles in the affected locations.

Photograph 4. View of Typical Corrosion on Downstream Pile of Pier 2, Looking South.

- (A) Reinspect the submerged substructure units at the normal maximum recommended (NBIS) interval of five (5) years.
